General Technical
Report INT-245

July 1988

Fire Retardant- Caused Corrosion— A 1986 Field Reassessment

Fire Retardant-Caused Corrosion—A 1986 Field Reassessment

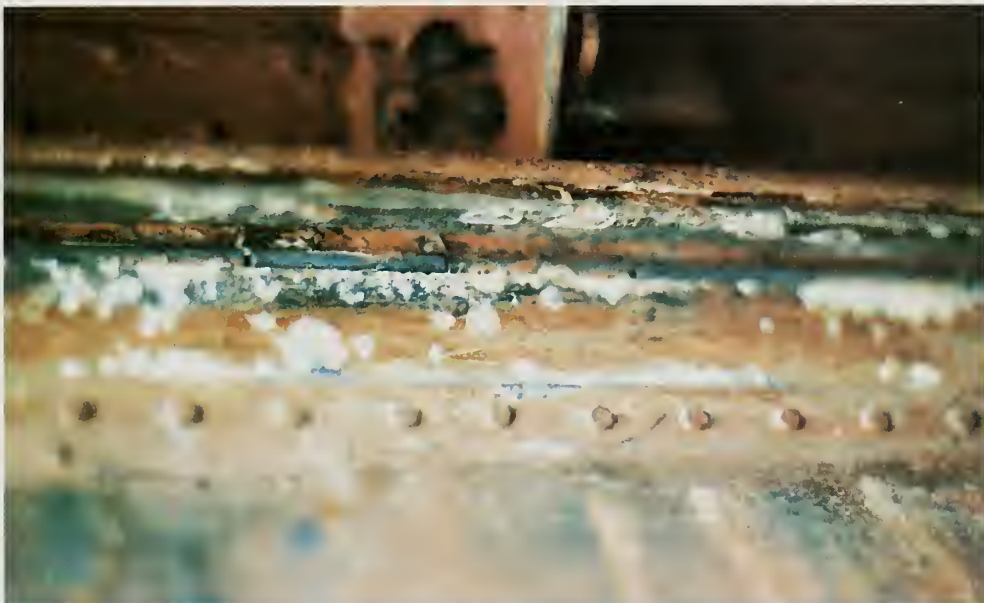
Figure 1—Pitting corrosion of aluminum tank gate.

1. Pitting corrosion of aluminum tank gates and solenoids (figs. 1, 7, and 11)

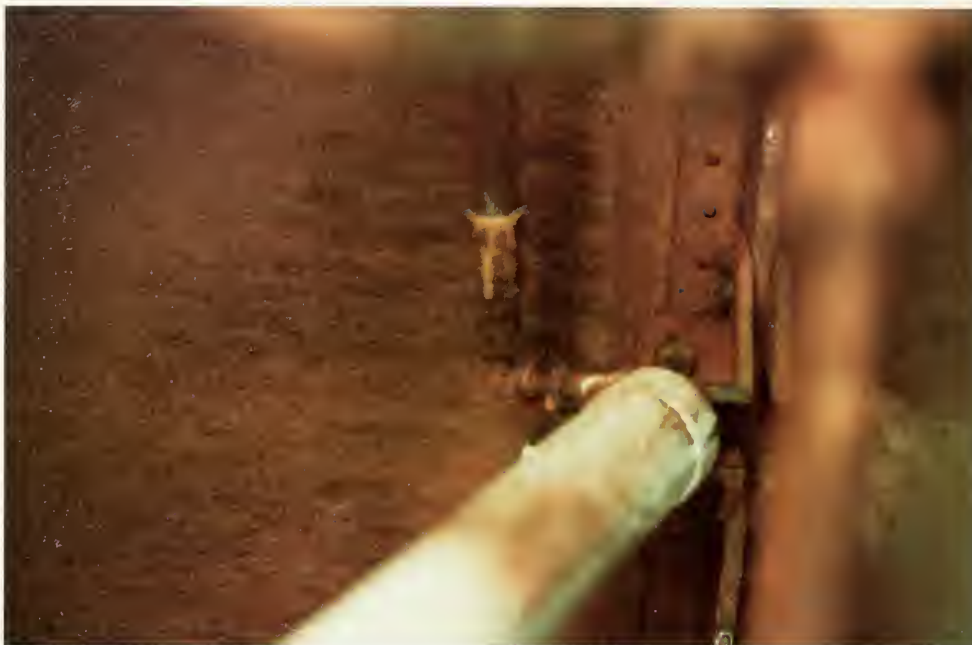
Figure 2—Corrosion of steel end fitting on Aeroquip hydraulic hoses.

2. Corrosion of steel end fittings on Aeroquip hydraulic hoses (fig. 2)

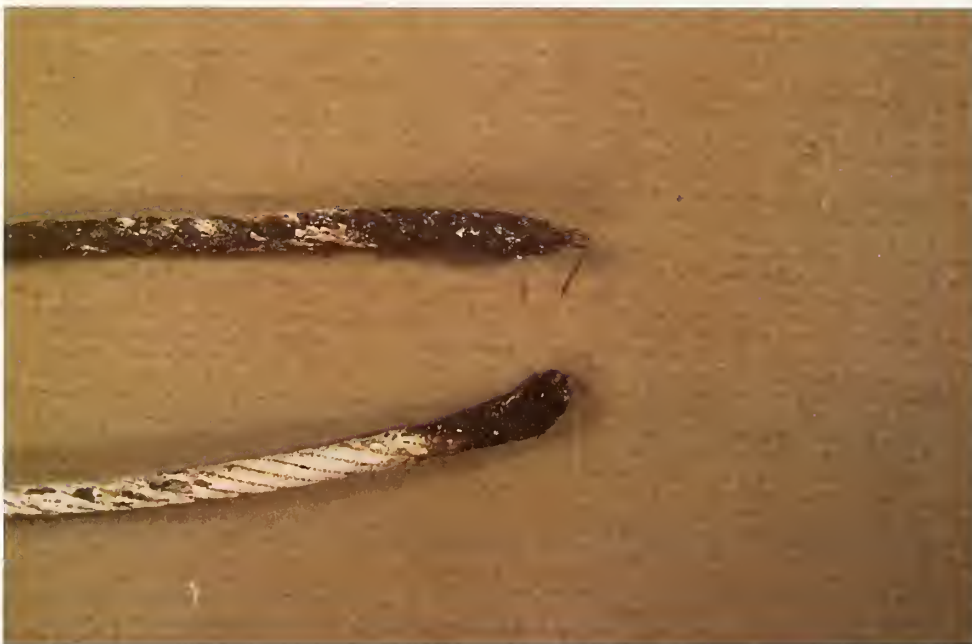
Figure 3—Failure of stranded steel cable.

3. Corrosion of stranded steel cabling (figs. 3 and 8)

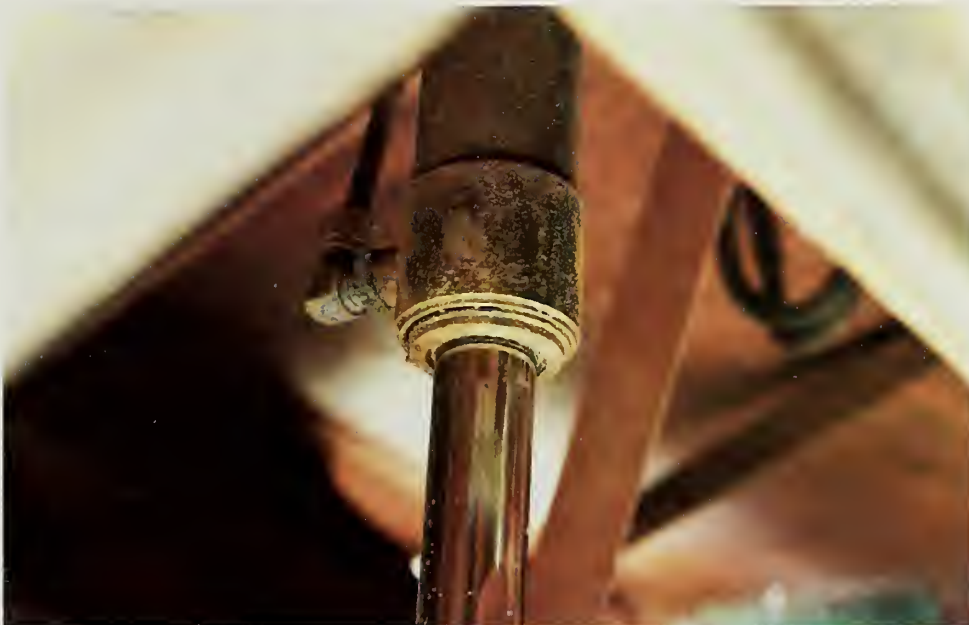
Figure 4—Corrosion of steel hydraulic piston barrel.

4. Corrosion of steel hydraulic piston barrels and seals (figs. 4 and 12)

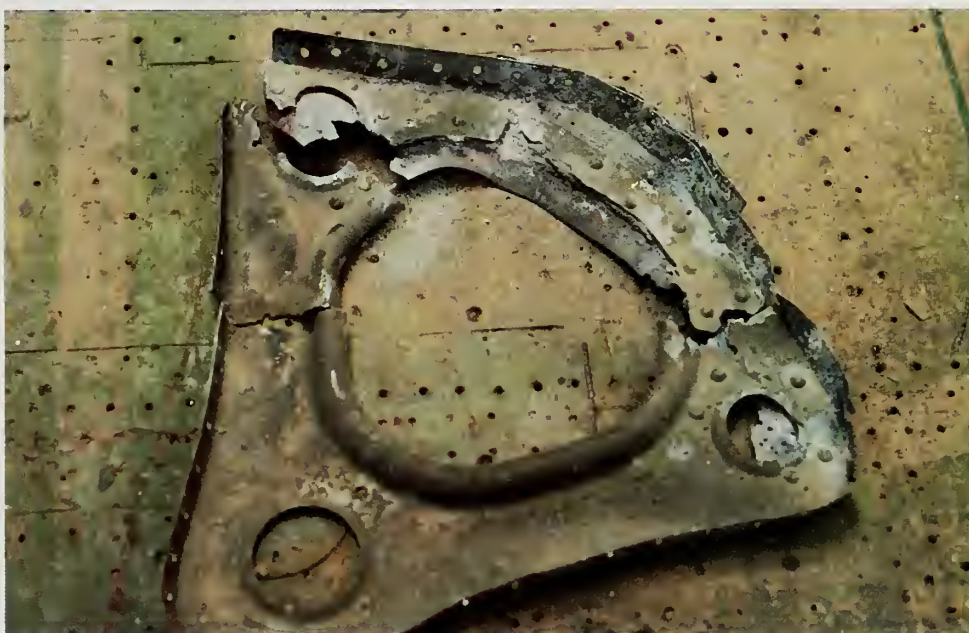
Figure 5—Corroded aluminum structural stiffener from DC-6 tail cone.

5. Internal corrosion of aluminum DC-6 tail cones (fig. 5)

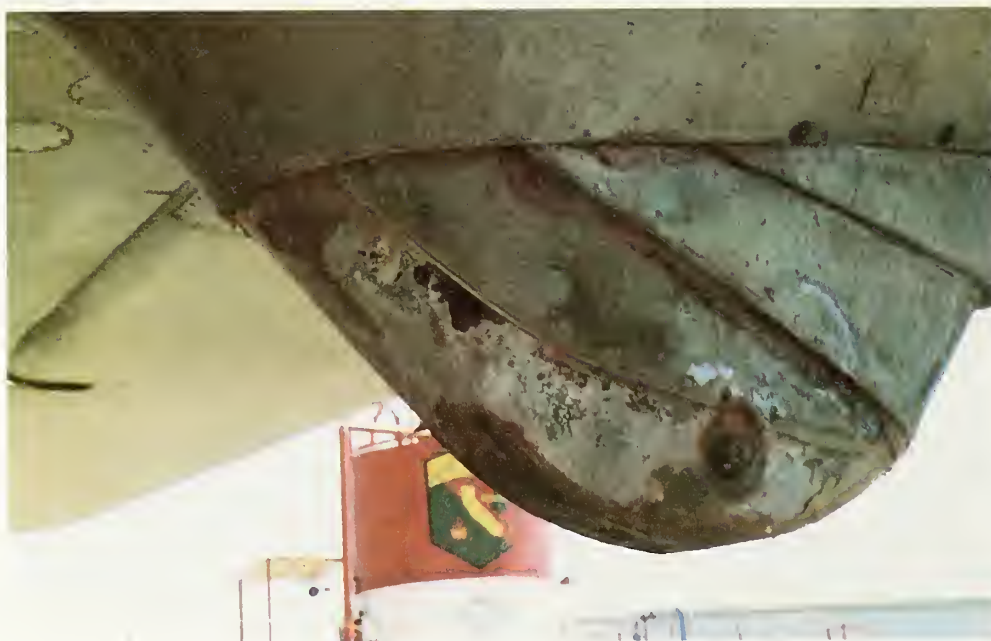
Figure 6—Corrosion of aluminum tail skid.

6. Corrosion of aluminum tail skids (fig. 6)

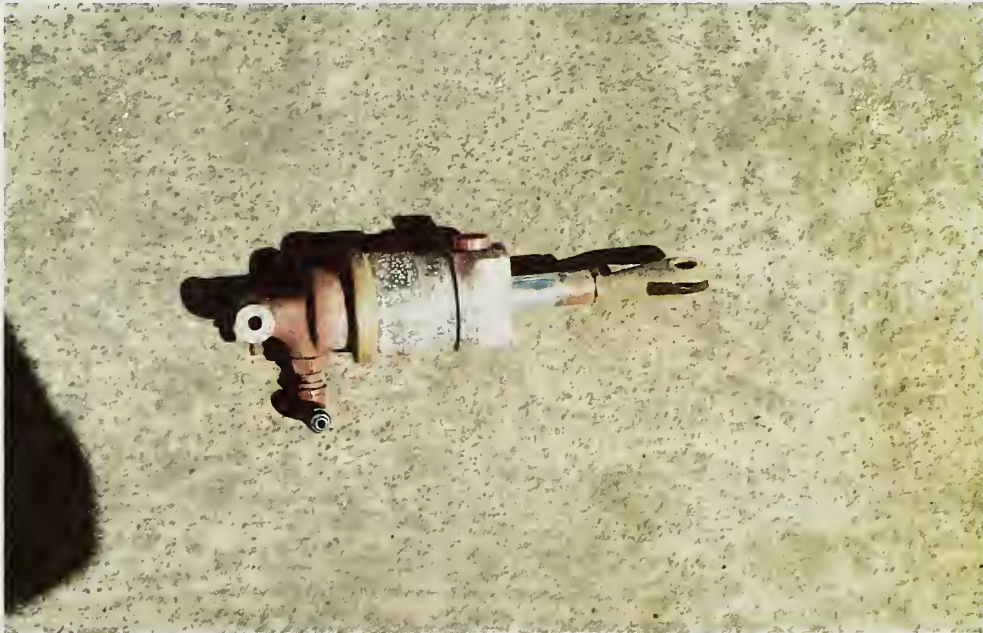
Figure 7—Corroded tank gate solenoid.

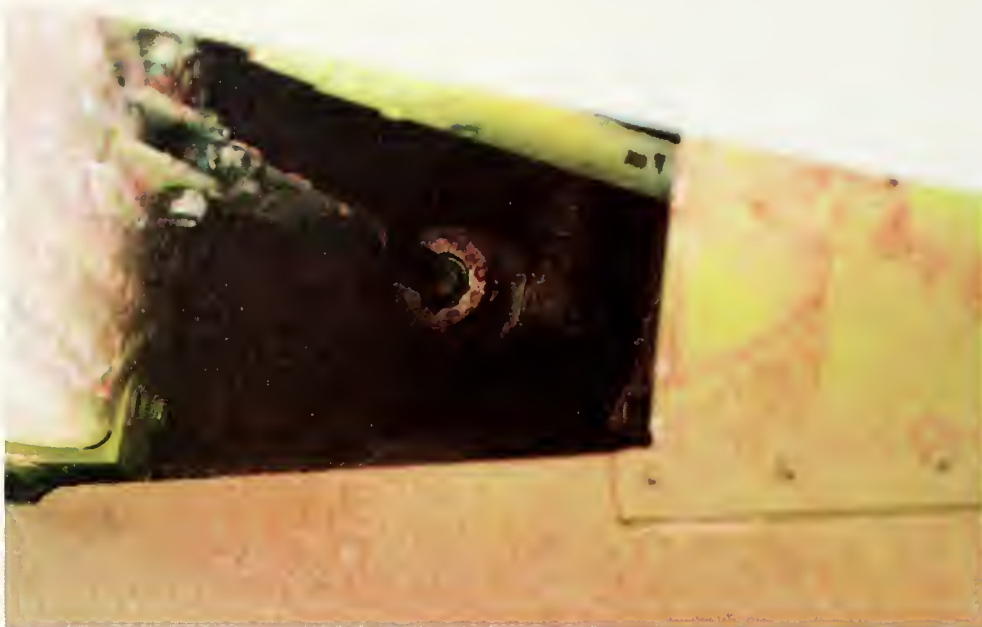
7. Corrosion of steel rear wheel retraction pistons and cylinder pins on S-2's (figs. 9 and 10)

Figure 9—Corrosion of attached rear wheel retraction piston.

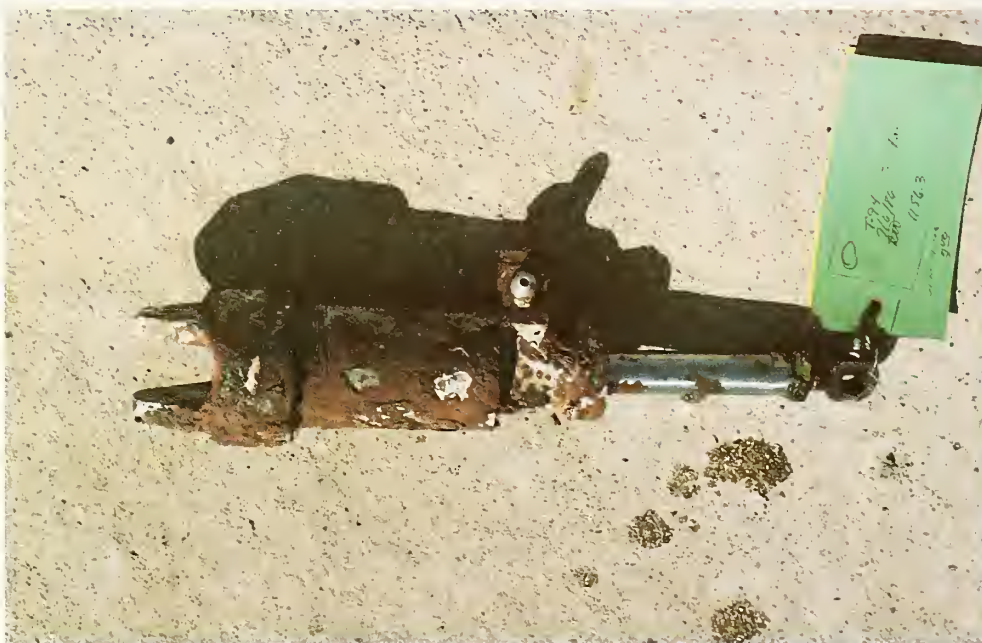
Figure 10—Corroded rear wheel retraction piston.

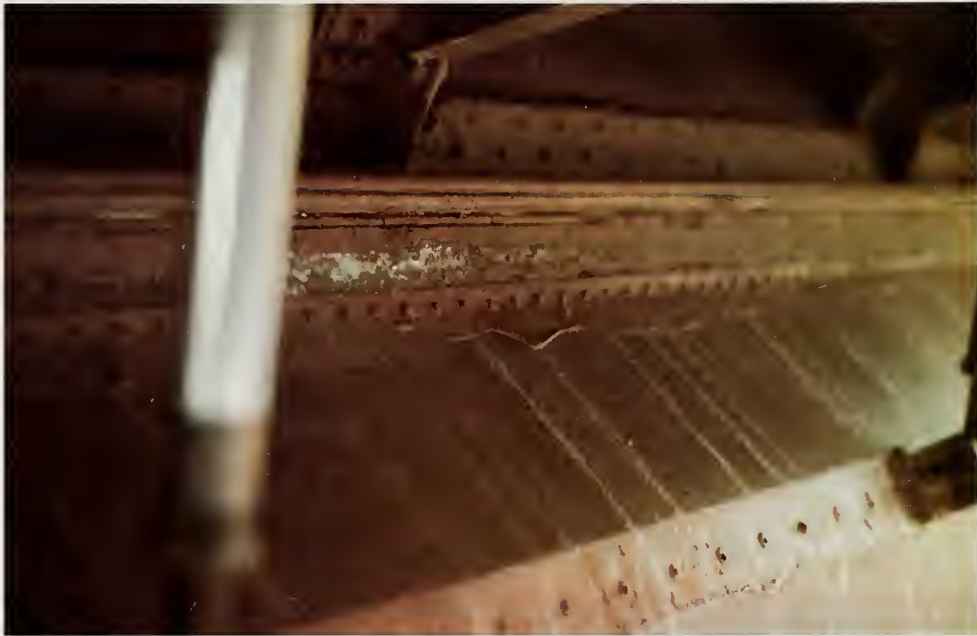
Figure 11—Pitting of aluminum tank gate.

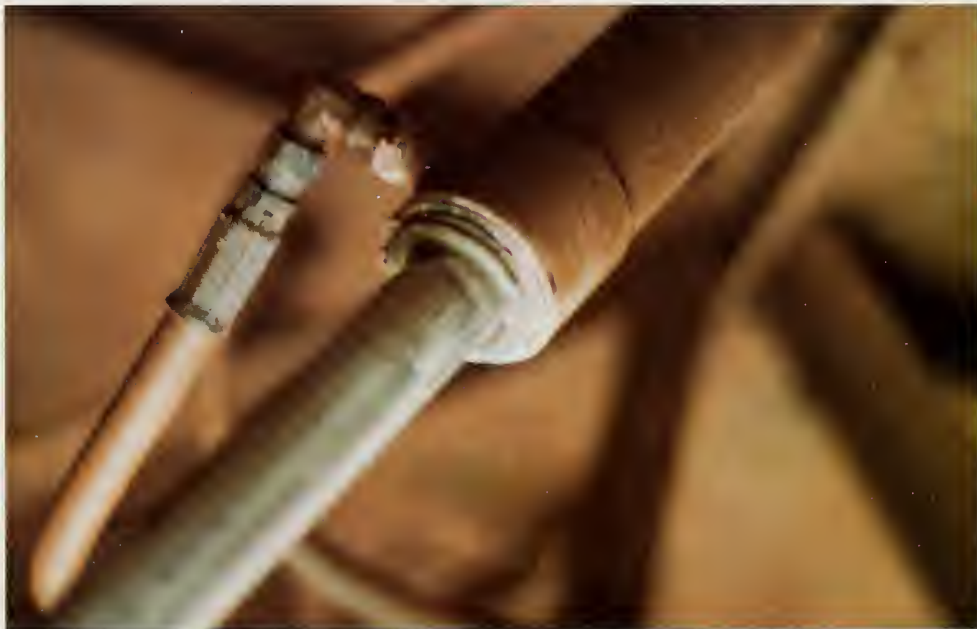
Figure 12—Corrosion of piston seal.

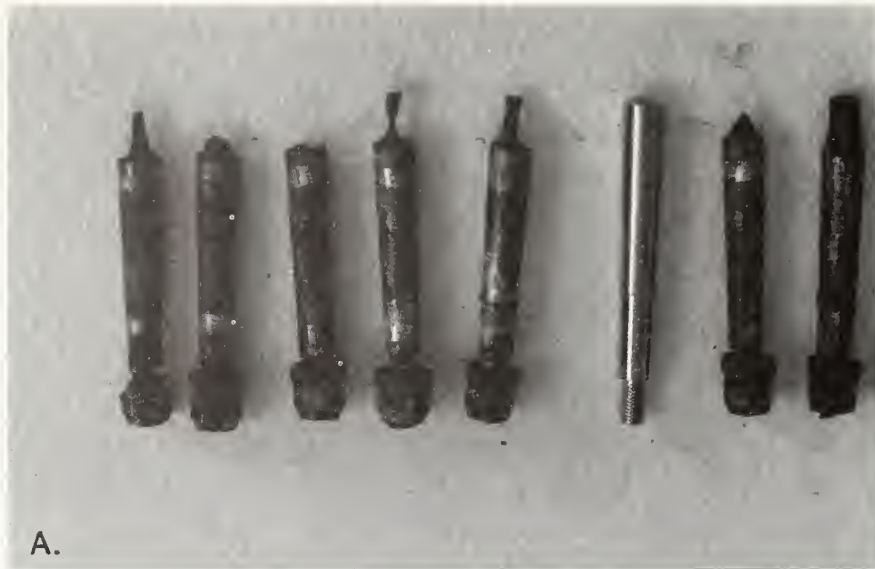
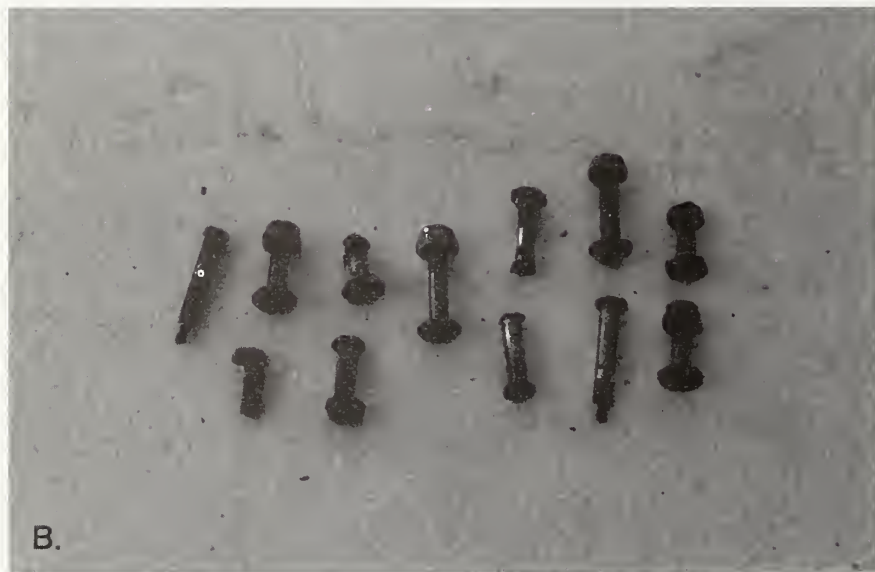
8. Corrosion of steel fastener hardware (figs. 13a and b)

Figure 13—Corroded steel fasteners: (A) steel torque tube taper pins, (B) miscellaneous steel fasteners used in door opening assembly.

Many of those interviewed contended that the new formulations (Fire-Trol GTS, Phos-Chek D75) are causing corrosion problems not observed previously. Specifically noted were accelerated corrosion of exposed steel fastener hardware and steel hydraulic components in tanks and corrosion of aluminum torque arms. Given the observations of the survey team and the frequency of the complaint concerning corrosion of steel hardware exposed in tanks, it would seem that attention should be given to this particular problem. The reported rate of corrosion attack (for instance, severe necking of bolts in one fire season) appears to be much greater than would be expected from approved retardants. The Forest Service fire retardant specification requires that approved retardants corrode

4130 steel at less than 5.0 mils per year (mpy) under specified partial immersion conditions. The reported attack is far in excess of this rate. Given the small area of steel as compared to aluminum in a typical tank, the problem suggests the presence of galvanic corrosion. Based on previous laboratory studies, steel was ordinarily electrochemically less active than aluminum and, thus, would not be expected to galvanically corrode when coupled to aluminum. But there were exceptions—specifically, in Fire-Trol 100, an ammonium sulfate-type retardant. (Both new formulations, Fire-Trol GTS and Phos-Chek D75 are ammonium sulfate-based retardants.) Thus, there is a need to investigate the propensity for galvanic corrosion between steel and aluminum in the new retardant formulations.

Some of the above problems can be solved without modifying the chemical corrosivity of the approved retardants. For example, corrosion of steel fastener hardware in aircraft tanks was mitigated in several airtankers by the judicious use of protective coatings/sealants or the substitution of stainless steel. At a certain point further modification of the retardant formulations to reduce corrosivity will prove less cost effective than other measures (for example, use of protective coatings, substitution of more resistant alloys). Some of those measures have been described in the recent publication "Guidelines for Preventing Fire Retardant Corrosion" (fig. 6).

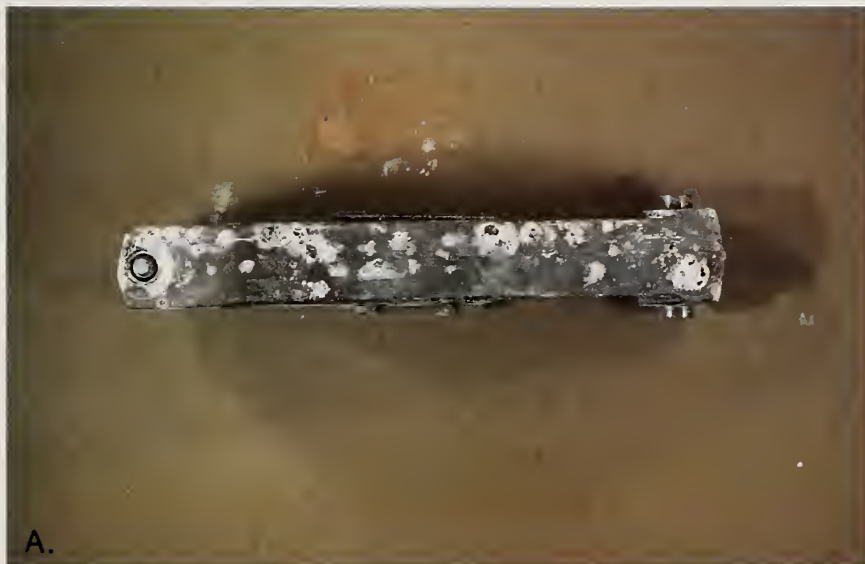
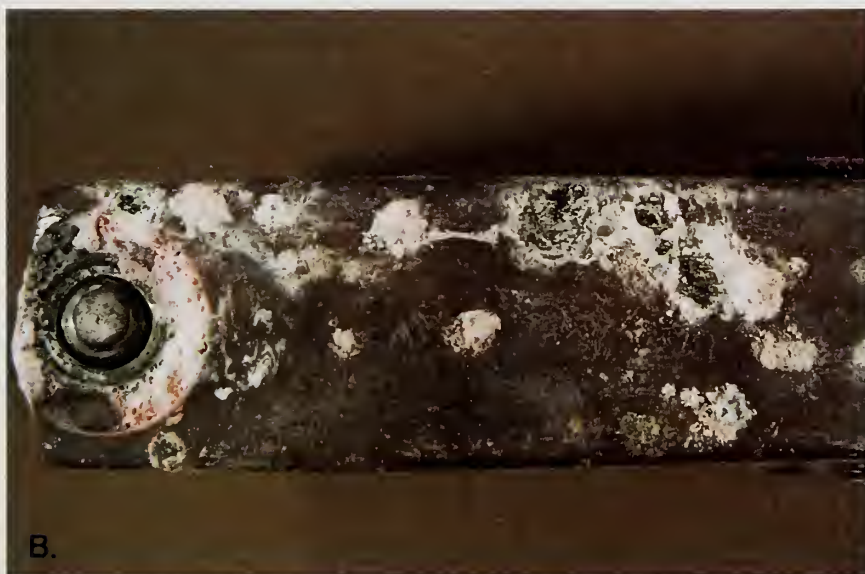
9. Corrosion of aluminum torque arms (figs. 14a and b)

Figure 14—Corroded aluminum torque arm: (A) general view, (B) pitting at attach point.

19	Corrosion of torque arms.	Corrosion attack (pitting) observed on aluminum (Tenzaloy) torque arms.	Reported by representatives of contract airtanker operator.	14a,b	Representatives of contract airtanker operator advise corrosion occurred in one fire season (3 mos) in PC-D75 with aircraft sitting loaded.
20	Corrosion of steel bolt heads.	Corrosion attack reported on bolt heads in several tanks.	Reported by representatives of contract airtanker operator.	—	Reported as problem occurring only in recent years.
21	Corrosion of rear wheel retraction piston.	Same as 11.	Reported by representatives of contract airtanker operator	—	Airtanker operator advised continued problem on S-2 rear wheels; rear piston had to be replaced after 118 hours because of corroded cylinder seal.
22	Corrosion of rear wheels.	Surface corrosion of rear wheel bearing races.	Reported by representatives of contract airtanker operator	15	Airtanker operator advised rear wheels have to be replaced every 1-2 years because of corrosion of bearing races.

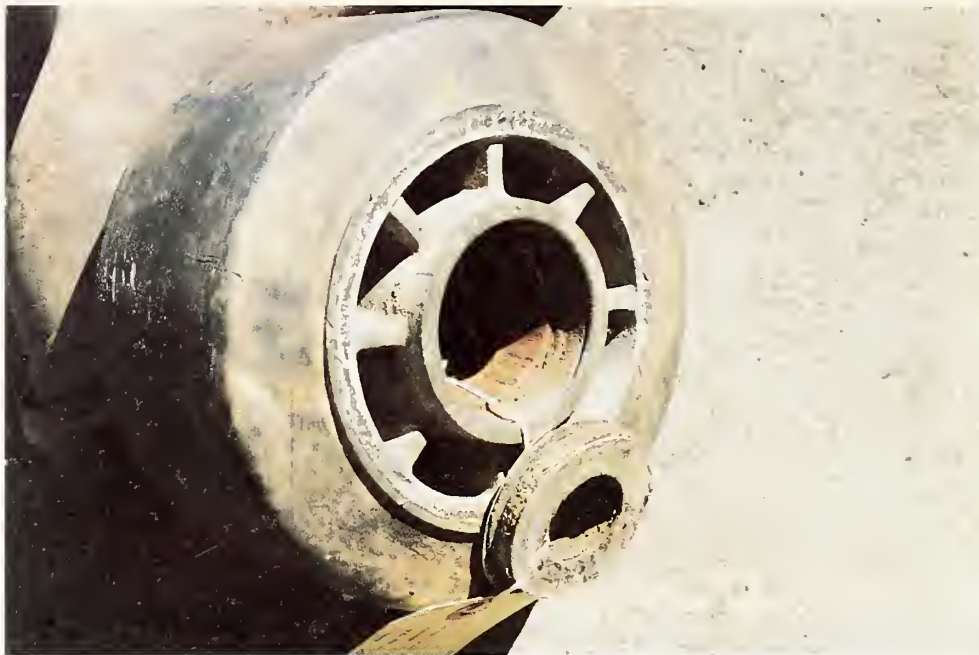
10. Corrosion of steel S-2 rear wheels and bearing races (fig. 15)

Figure 15—Corroded rear wheel removed from an S-2.
